## SIB 61 01 21 48 VOLT BATTERY MAINTENANCE

This Service Information Bulletin (Revision 3) replaces SI B61 01 21 **dated July 2021**.

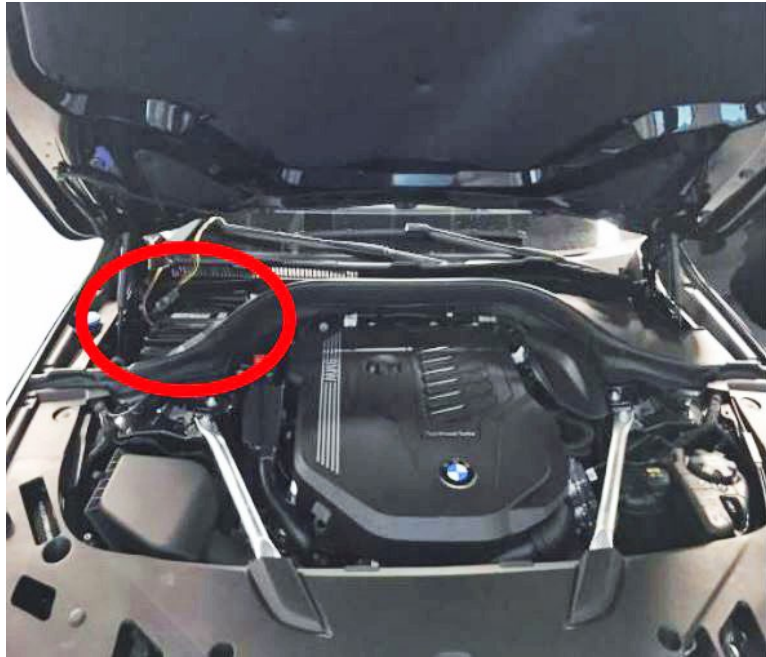
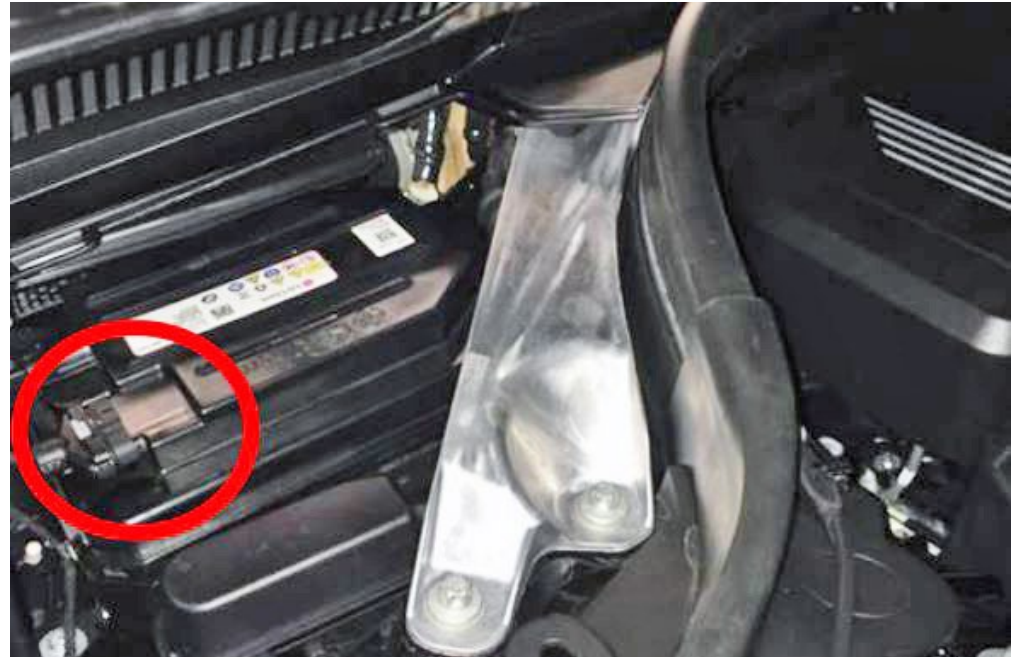
[picture\\_as\\_pdf B61 01 21 Attachment January 2021.pdf](#)

Disconnect the mains/signal connector **G14\*1B** of the BATT48 (see attachment).

**The 12V battery must be fully charged before unplugging the 48V signal connector.**

Before the vehicle is driven again on the road, it is important to plug in the connector delete the fault memory using ISTA.
